Inspection Report Minerals Regulatory Program June 24, 2013

Mine Name: Black Sands 472288	Permit Number: S/047/0086
Operator Name: Black Sands Holding Co.	Inspection Date: 06/18/2013
Inspector(s): Tom Nicolaysen (intern)	Time: 3:00 PM
Other Participants:	Mine Status: Inactive

Inspection of reclamation for bond release

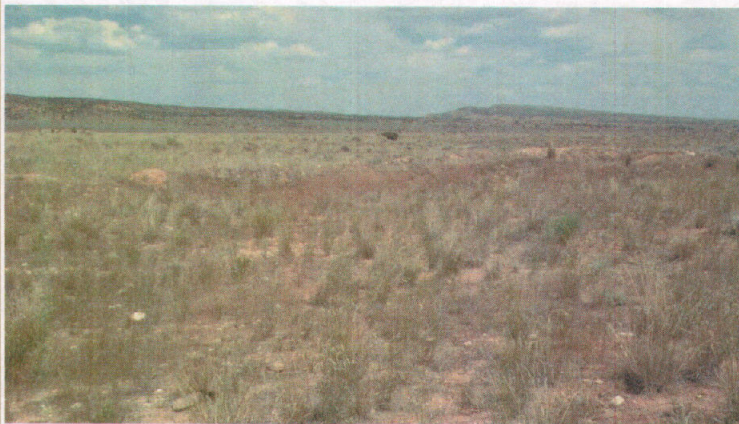
First drill site to the south east. Re-vegetation and no substantial surface disturbance. UTM NAD 83: E 614382.56, N 4475009.82

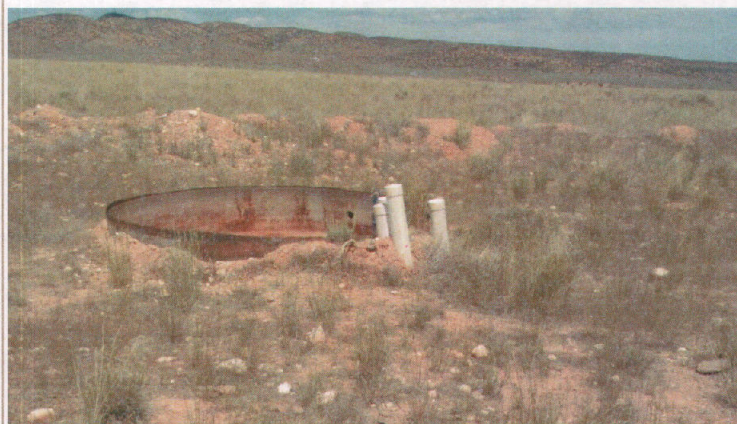
Basin and PVC pipe in the ground with a berm around it near the drill site. This may be post mining disturbance.

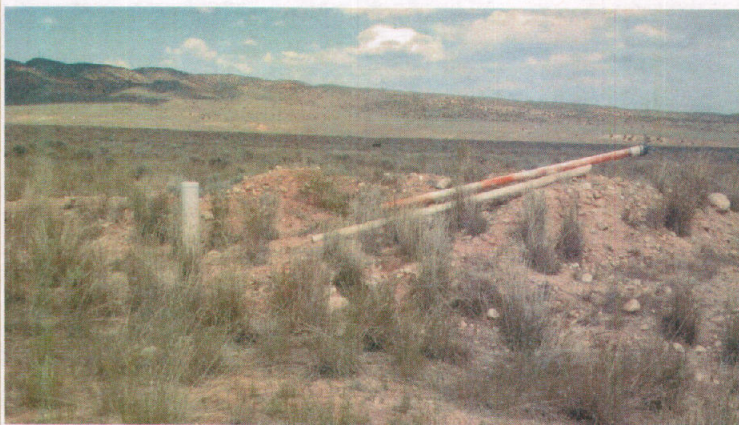
Another burned area to the north west of the first site with some PVC laying on top. There are some capped wells, one uncapped which is only approx. 4 feet deep.

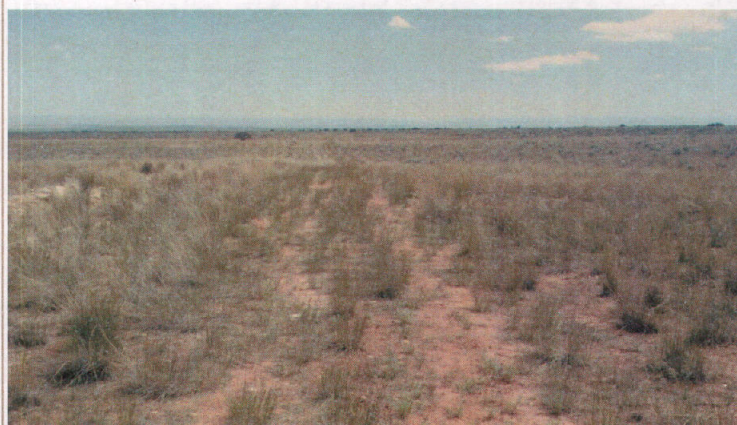
An access road between the two burned areas. This may be post mining activity.
